FP Industry 4.0 Communicator

FP-I4C Firmware Update

Quick Start Guide
Release Information

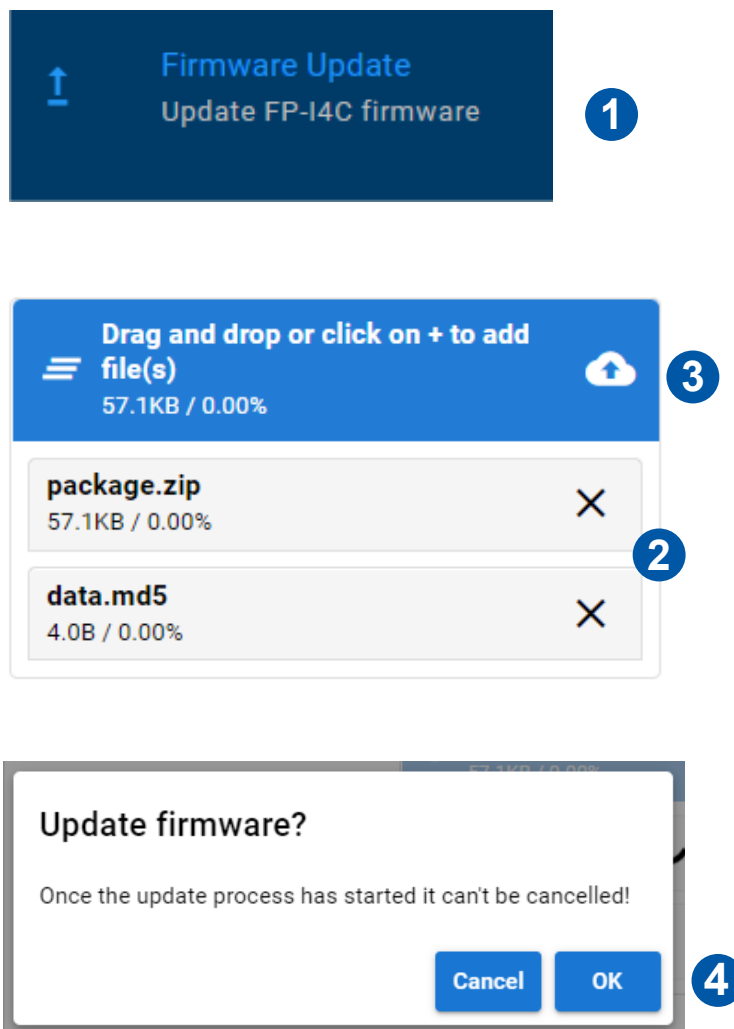
1. Open your browser and enter the URL `https://[IP address]/machine_config`. Replace [IP address] with the IP address of your FP-I4C unit (e.g. `https://192.168.168.115/machine_config`).
Depending on your browser, an insecure connection warning may be displayed. Follow the instructions in your browser to accept the connection. You will then be forwarded to the Web interface of the FP-I4C unit.
2. Select "Application Settings" to go to the application settings area.
3. Follow these steps:

During and after the update, status windows are displayed.

When the update is completed, the unit reboots automatically and the “Firmware Update” page is refreshed after a short while. If the update was successful, the new version number is displayed.
